# KILKENNY - COUNTY GEOLOGICAL SITE REPORT

<b>NAME OF SITE</b>	<b>Deerpark Mine</b>		
Other names used for site			
<b>IGH THEME:</b>	IGH 15 (Economic Geology)		
<b>TOWNLAND(S)</b>	Deerpark		
<b>NEAREST TOWN</b>	Castlecomer		
<b>SIX INCH MAP NUMBER</b>	5		
<b>NATIONAL GRID REFERENCE</b>	253394 175692 = S 533 756		
<b>1:50,000 O.S. SHEET NUMBER</b>	61	<b>1/2 inch Sheet No.</b>	19

Disused coal mine and old mine buildings.

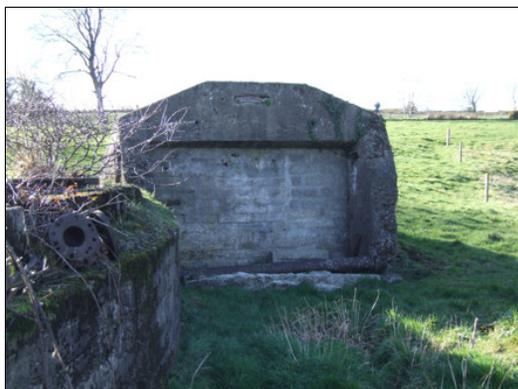
Left: The bricked up mine adit that once brought men and boys into the Deerpark Mine.  
Right: An artificial dam to the north of the main mining area, constructed to channel water for the purpose of processing materials extracted from the mine.
