UNIVERSITY COLLEGE DUBLIN

Effect of Climate Change On Slope Stability Problems

Dr. Ken Gavin

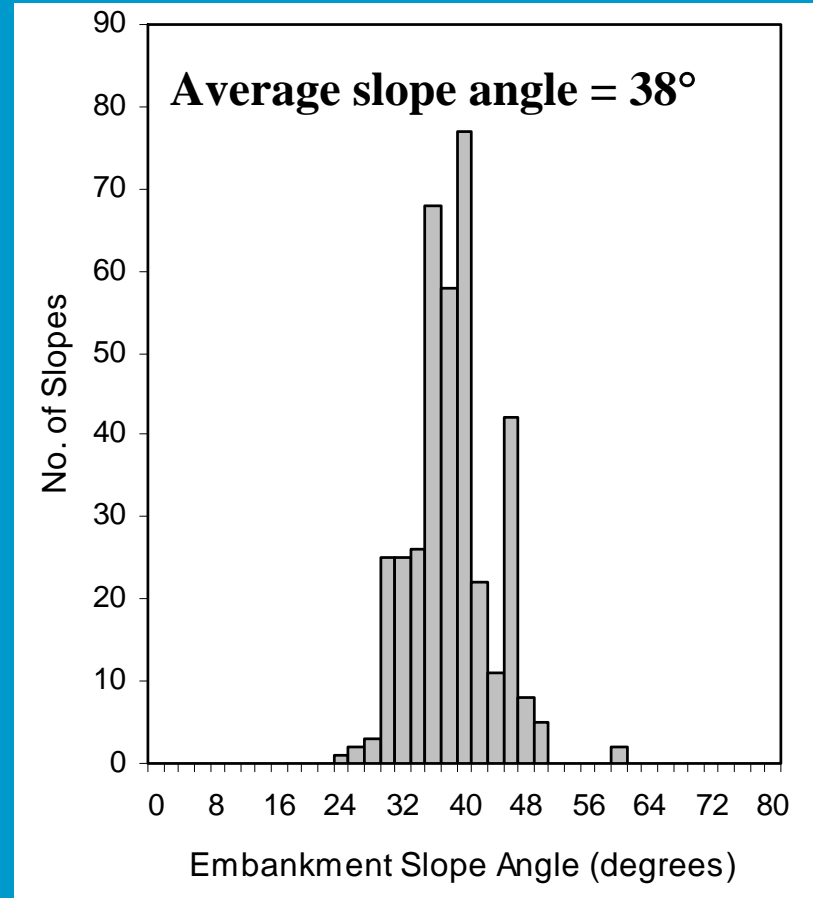
Survey of 150 year old railway embankments

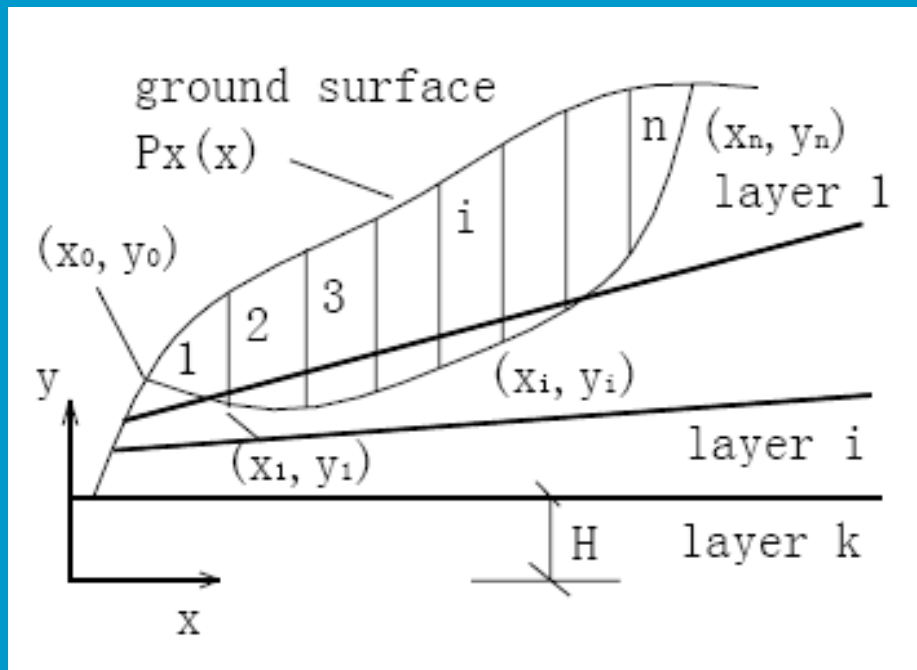
UCD Reliability Model - GASSA

Geotech reliability analysis of slopes usually assumes fixed soil properties to determine critical slip surface and the varies soil properties along this fixed surface to determine reliability

By using polar transformation UCD consider soils properties and slip coordinates as variables and solves simultaneously, invariant and computationally efficient

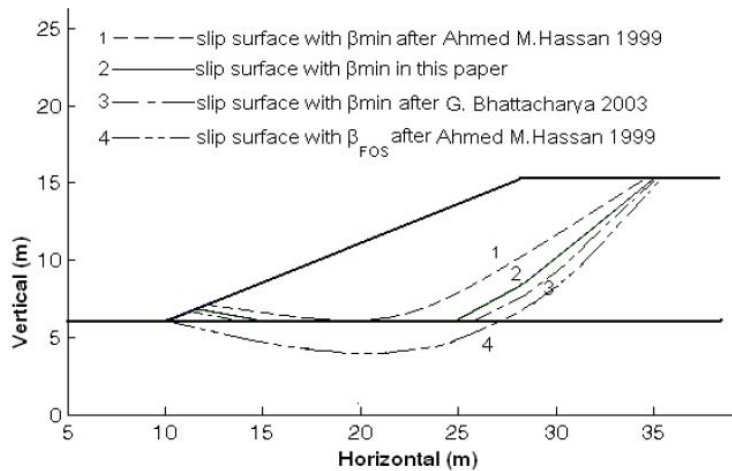
Performance of UCD model

- Method applied to benchmark 1:2 slope from the literature

- A range of soil properties Cases A-N were considered

- The relative performance of UCD model was best in all but one (Case H) of the fourteen soil profiles analysed, and in Case H all methods were broadly similar

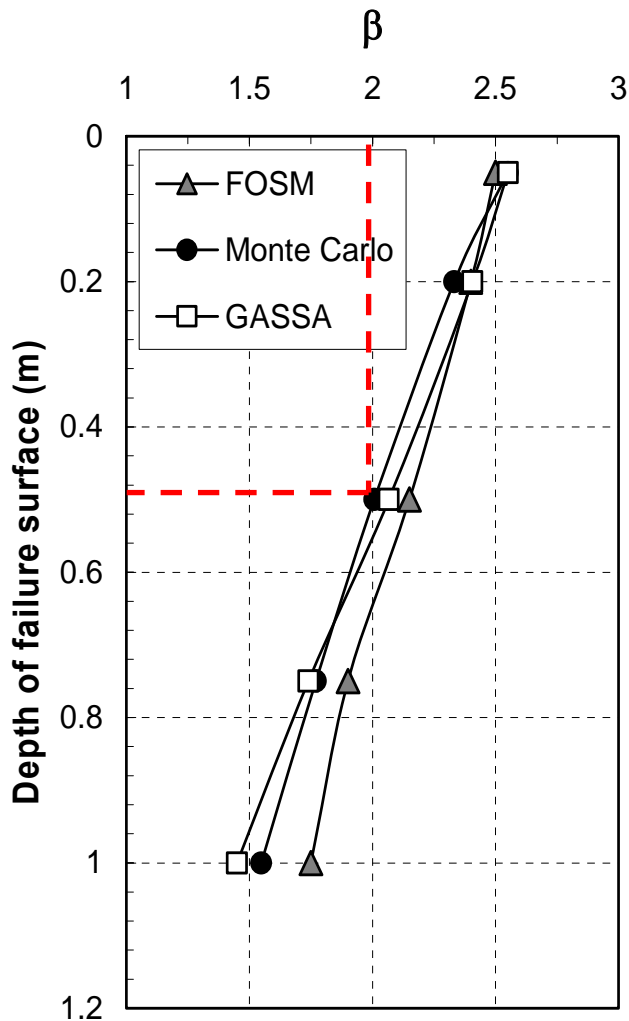
Partially Saturated Slope Analyses

- Model used to assess the performance of an instrumented slope in the Swiss Alps
- Measurements of suction, rainfall intensity and soil strength parameters were available. 0.5 m deep failure occurred after 45 hours into infiltration test.
- GASSA and Monte-Carlo give very similar results. Both suggest critical conditions ($\beta \approx 2$) when the wetting front depth reaches 0.5m.

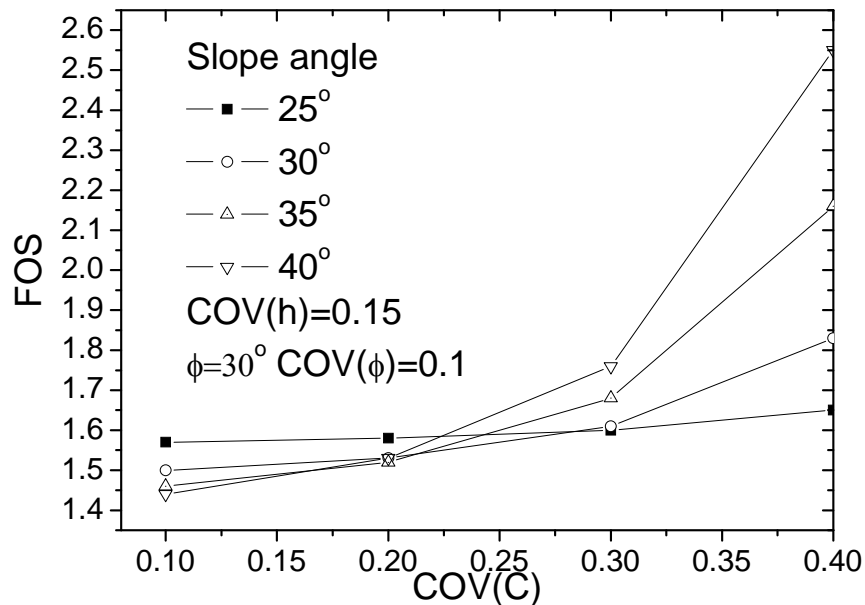
For Additional Uncertainty – Increase FOS

Possible reasons for additional uncertainty:

- (i) Untypical ground conditions
- (ii) Poor site investigation
- (iii) Complicated stratigraphy
- (iv) Lack of rainfall or other data
- (v) Natural variability

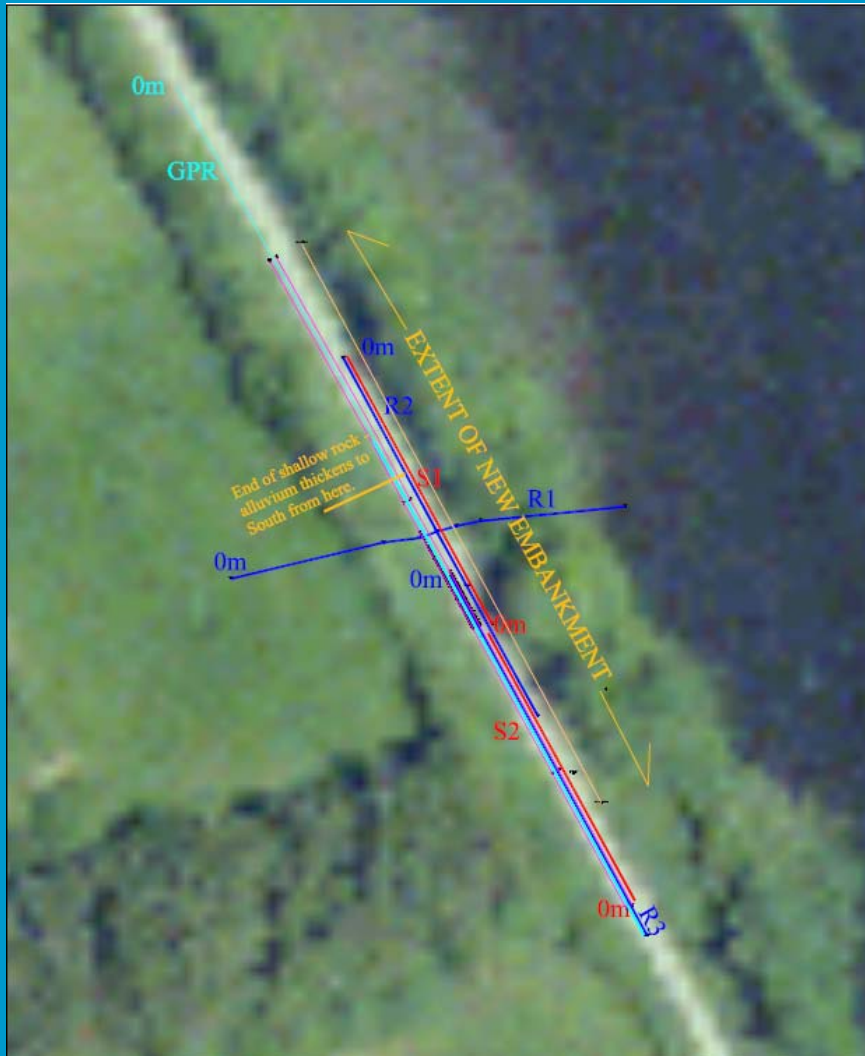
Conclusions - Case History

Complex ground conditions. The failure was triggered by heavy antecedent rainfall and the effects were amplified by creep in the soft clay deposit. Geophysics offered key insights for low-cost
