LONGFORD - COUNTY GEOLOGICAL SITE REPORT

NAME OF SITE	St. Mel's Cathedral		
Other names used for site			
IGH THEME	IGH15 Economic Geology		
TOWNLAND(S)	Townparks		
NEAREST TOWN/VILLAGE	Longford		
SIX INCH MAP NUMBER	13		
NATIONAL GRID REFERENCE	613440E 775300N		
1:50,000 O.S. SHEET NUMBER	41	GSI BEDROCK 1:100,000 Sheet No.	12

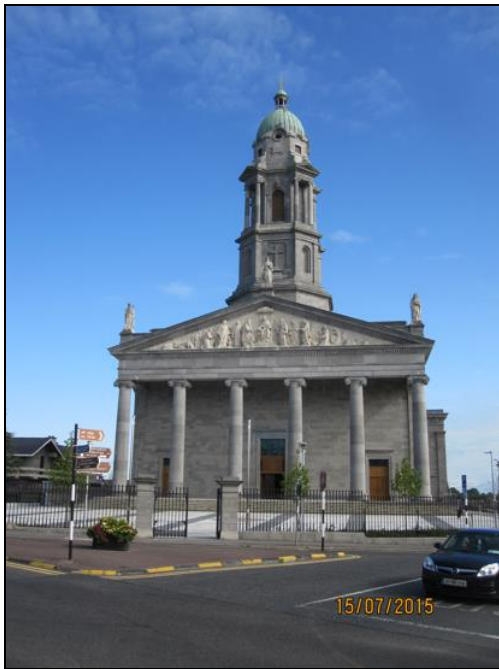
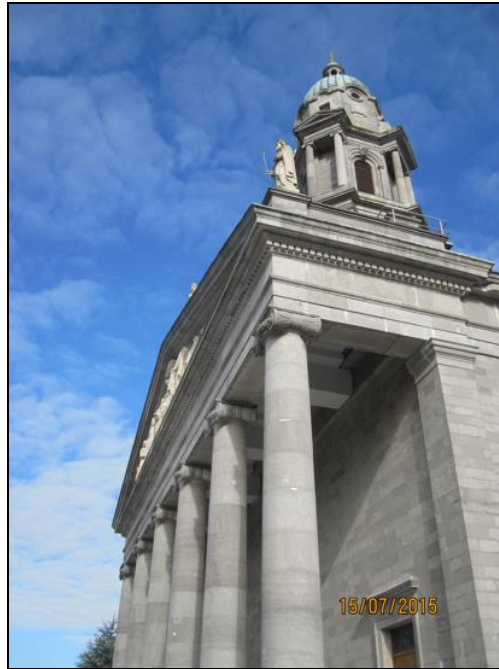
The exterior façade of St. Mel's Cathedral, Longford.

The high altar is composed of Carrera marble. The portico of great limestone columns from Knockcroghery in Roscommon was only commenced in 1891, and greatly enhances the building's grand façade. The statuary on the tympanum of the façade is in Portland Stone. The copper roof was destroyed in the fire but has been replaced by Bangor Slates, as first built, with stone from the original quarry source. Other chapels and elements inside the Cathedral use a variety of rocks and minerals in the decoration or construction.

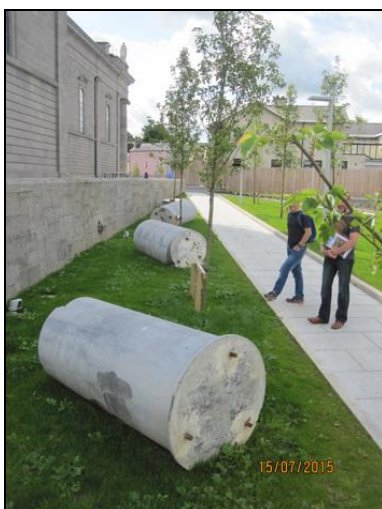
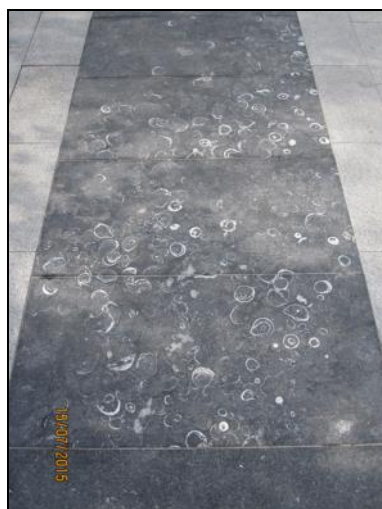
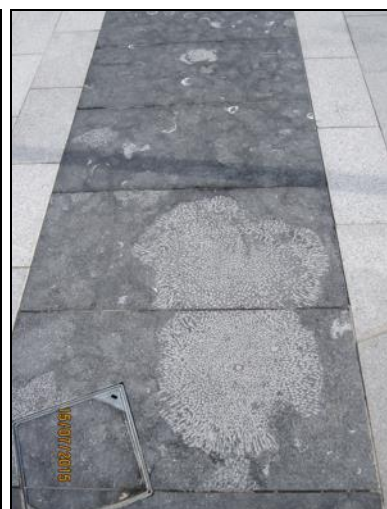
Left: Column in sections alongside the cathedral. Middle and Right: Paving with brachiopod shells (L) and colonial corals (R).

At Christmas 2009 a fire devastated the building, destroying the roof and the floor and generating such heat that much of the stonework including the main pillars were irreparably damaged. A massive restoration project, costing around €30m, was commenced which replaced significant parts of the building, and required both traditional and modern building skills and innovative work practices to complete the work by Christmas 2014. Whilst many of the elements of great public interest are the religious iconography, artworks and artists involved, the geological elements are also very significant. In particular the total replacement of 28 massive columns of limestone with stone quarried from Old Leighlin in Carlow is most notable.
