Lorrha Water Supply Scheme

Groundwater Source Protection Zones

Kevin Motherway, Natalya Hunter Williams & Geoff Wright
Geological Survey of Ireland

April 2002

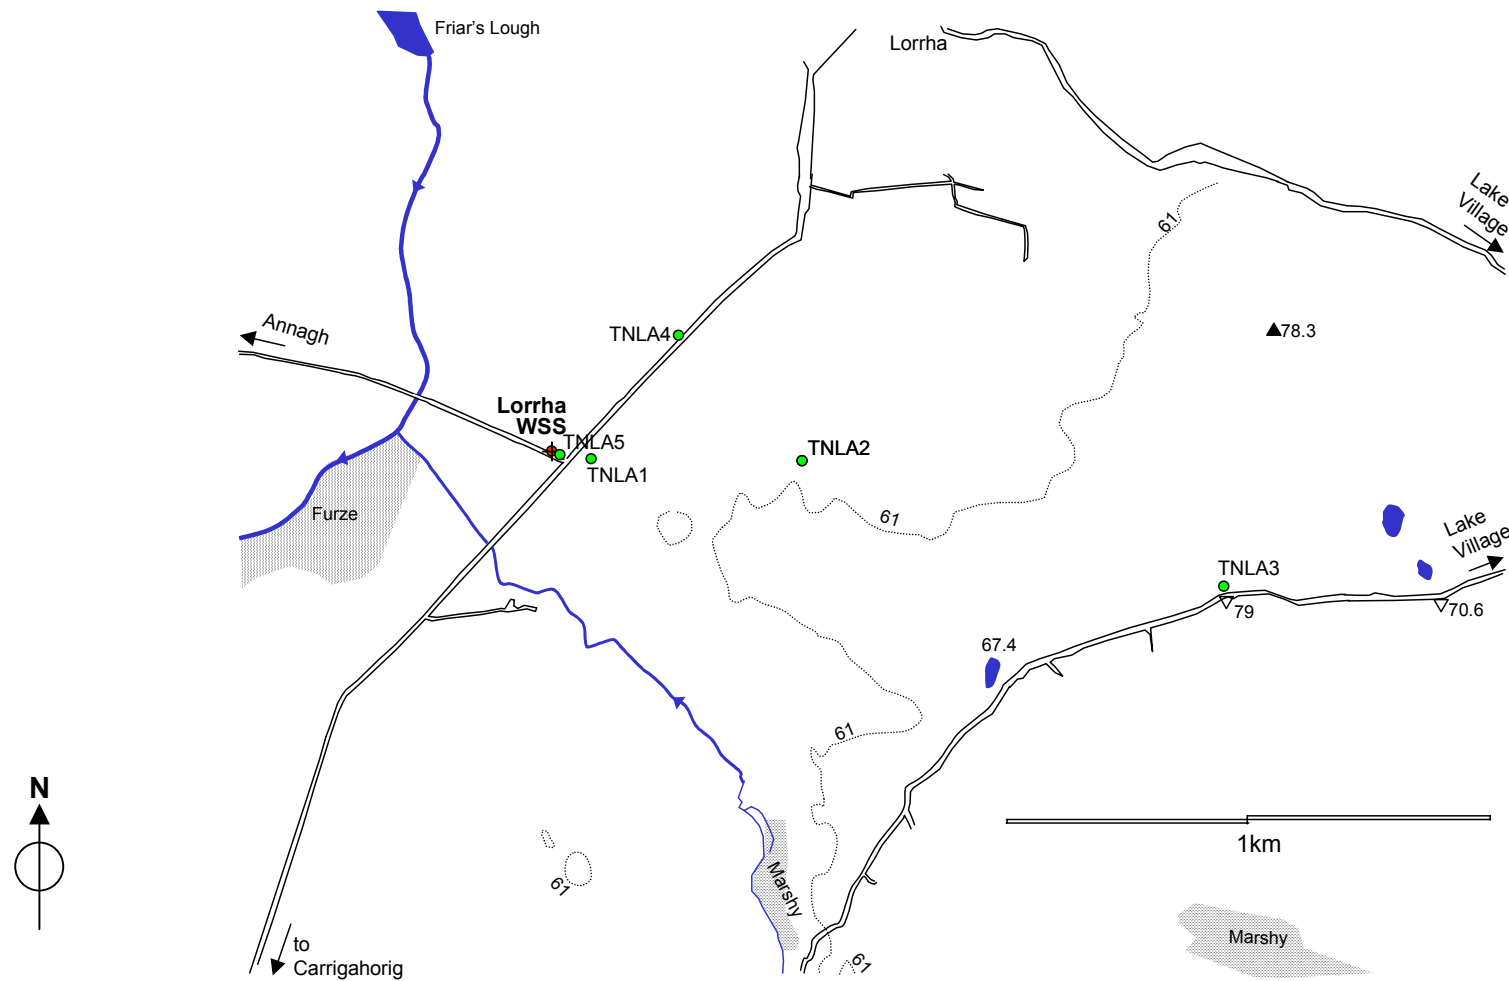
Figure 2: Location map of Lorrha WSS production borehole
 Showing auger holes drilled by GSI to determine depth to bedrock in the vicinity (TNLA1 to TNLA5) and other hydrogeological features discussed in the text.

The depth to rock is known at selected localities from a drilling program undertaken for this study by the GSI to ascertain the thickness and type of the subsoils. The locations of the five auger holes are shown on Figure 2, and the logs are summarised in Figure 3. Depths to bedrock range from 1.0 to 12.5 m. Near the borehole it is about 12.5 m.

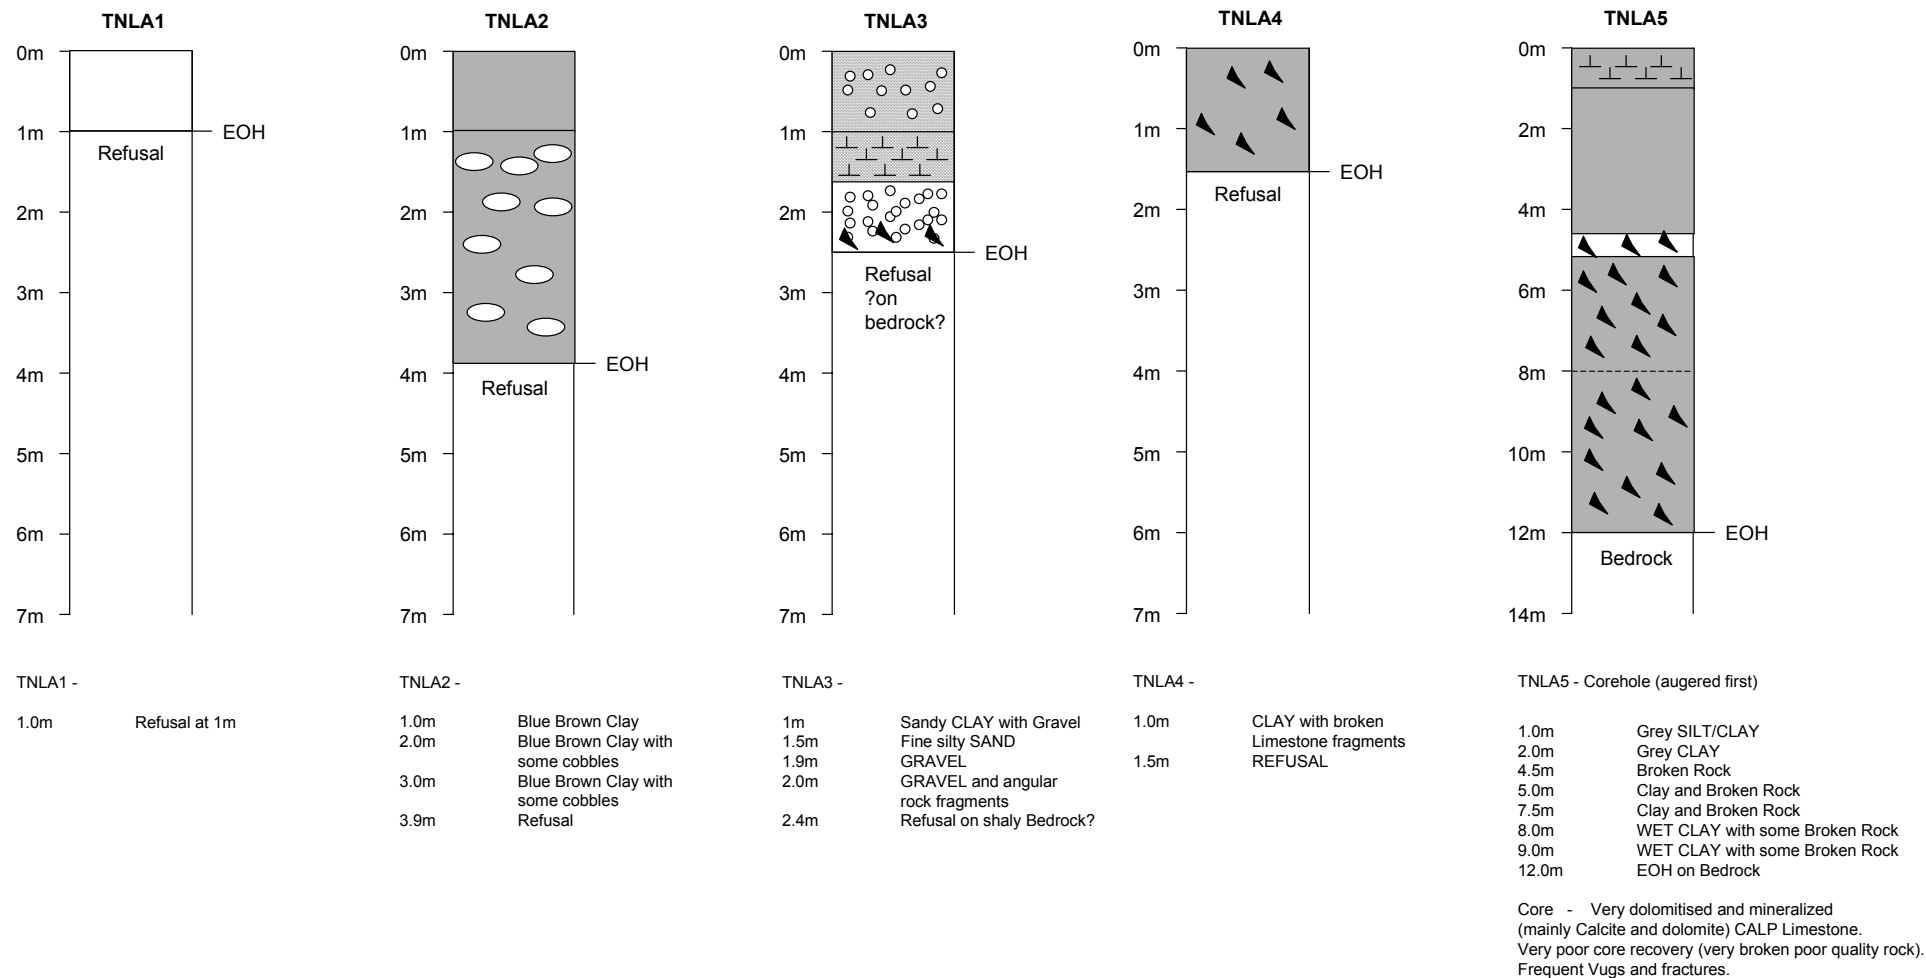
Figure 3: Summary logs and lithological descriptions of auger holes drilled to assess depth to bedrock in the vicinity of Lorrha WSS boreholes. See Figure 2 for the locations of the auger holes.

In the vicinity of the source, the soils are classified as having limestone till parent material by Teagasc (Finch and Gardiner, 1993). GSI augering reveals subsoils composed of clayey tills, sometimes with cobbles, rock fragments or gravels (see Figure 3).

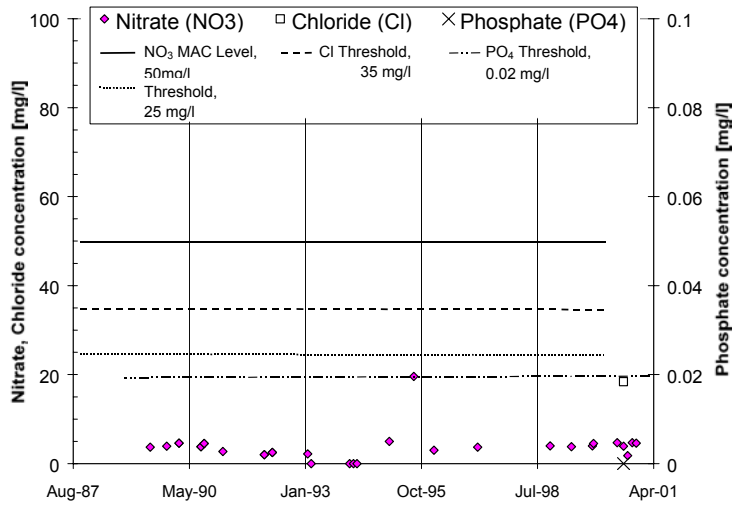
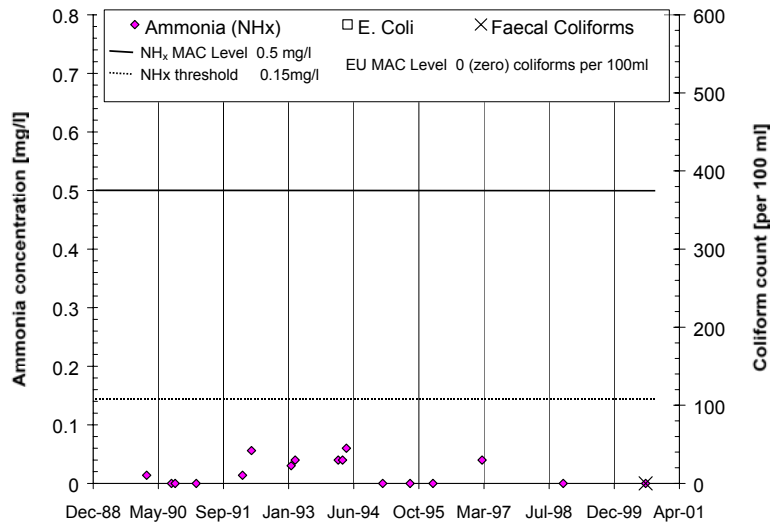
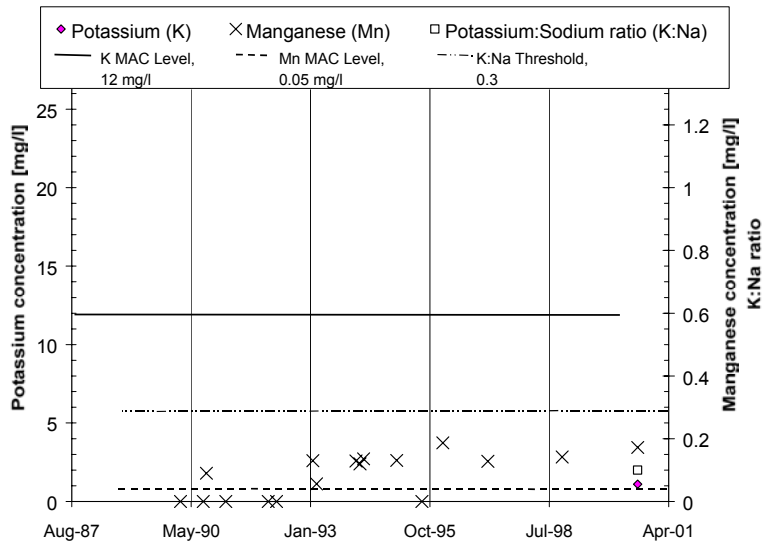
Figure 4: Key indicators of agricultural and domestic groundwater contamination at Lorrha WSS.

Field measurements indicated an electrical conductivity of 750 $\mu\text{S}/\text{cm}$ and a temperature of 10.7°C. Results of laboratory analyses of water samples are presented in Appendix 1. Data that reflect water quality are shown graphically in Figure 4. The following key points are identified from the data:

- The groundwater samples indicate a calcium-bicarbonate ($\text{Ca} - \text{HCO}_3$) hydrochemical signature.
- Groundwater hardness is classed as 'very hard' (total hardness 399 mg/l as CaCO_3 , one sample).

- Nitrate concentrations are low, ranging between 1.79 and 5 mg/l (as NO_3), with an average concentration of 3.7 mg/l (26 samples) over the period June 1989 to November 2000. The GSI threshold of 25 mg/l was not exceeded in the sampling period. The results are representative of background nitrate levels, and no contamination is indicated.

- The single measured chloride concentration range was 18.4 mg/l (August 2000). Chloride is a constituent of organic wastes and (away from coastal areas) levels higher than 25 mg/l may indicate contamination, and above 30 mg/l usually indicate significant contamination. With one sample, no conclusion can be drawn, except to comment that the concentration falls within acceptable limits.
