MINANE BRIDGE WATER SUPPLY
GROUNDWATER SOURCE PROTECTION ZONES

Revised 2002

Denise Kelly & Geoff Wright
Groundwater Vulnerability Mapping by Una Leader
Groundwater Section
Geological Survey of Ireland

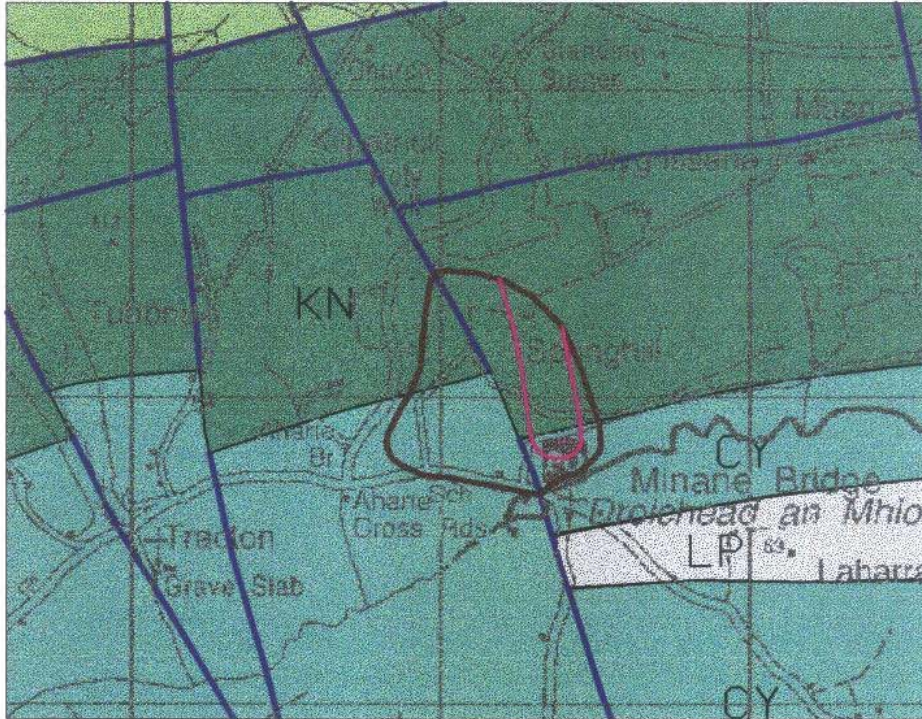
Map 1. Geology

Old Head Sandstone Formation
-   Courtmacsherry Formation
-   Kinsale Formation

-   Fault
-

The catchment is underlain by rocks of the 'Cork Group', including the Lispatrik Formation, Courtmacsherry Formation (Ringabella Member and Fountainstown Member), Kinsale Formation (Pigs Cove Member, Narrow Cove Member, Cuskinny Member, and Castle Slate Member), the Old Head Formation, and the Gyleen Formation.

The rock formations are folded into a small syncline (the Powerhead Syncline), which lies between the Church Bay Anticline (to the north) and another to the south. The axis of the folding is approximately WSW-ENE. The rocks are also broken by a strong system of faults running approximately NNW-SSE, or roughly at right angles to the fold axes. The faulting has generally resulted in moving the rocks to the east of each fault a little way to the south (i.e. they are dextral wrench faults). One such fault crosses the valley, just to the west of the Bridge.

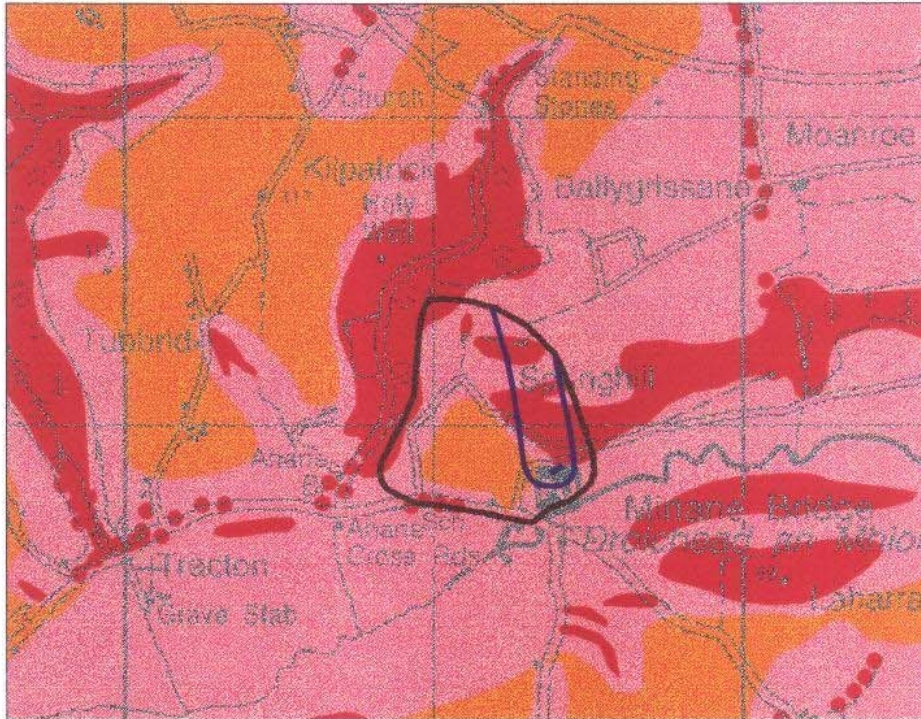
Map 2. Groundwater Vulnerability

Vulnerability is a term used to represent the intrinsic geological and hydrogeological characteristics that determine the ease with which groundwater may be contaminated by human activities.

The map shows the vulnerability of the first groundwater encountered (in either sand/gravel aquifers or in bedrock) to contaminants released at depths of 1-2 m below the ground surface. Where contaminants are released at significantly different depths, there will be a need to determine groundwater vulnerability using site-specific data. The characteristics of individual contaminants have not been taken into account.

The gravel aquifer is protected by only a thin layer of alluvial silt clay and peat, which appears to be less than 3 metres thick. Hence, the groundwater vulnerability category around the gallery and on the alluvial flat is 'extreme' (*E*).

Away from the alluvial flat, the vulnerability depends mainly on the subsoil thickness or depth to bedrock. Where this is less than 3 m, the vulnerability is 'extreme'; where it is greater than 3 m, the vulnerability is classed as 'high (possibly moderate in places)'.

The extreme vulnerability areas cover the hill slopes bordering the alluvium, except for a couple of small areas to the northeast and east of Minane Bridge (Map 2).

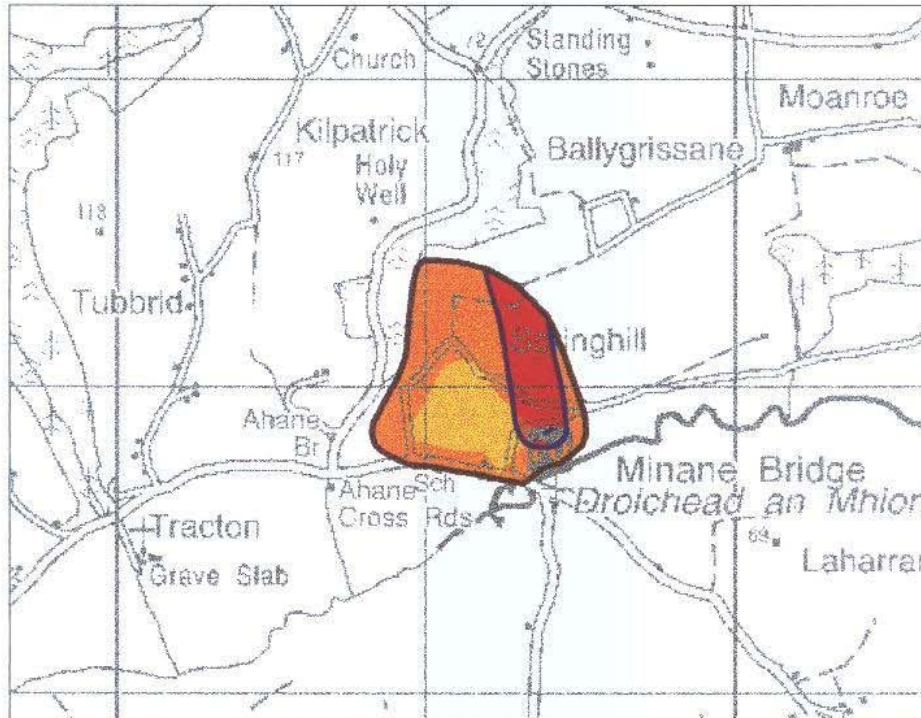
Map 3. Source Protection Zones

VULNERABILITY RATING	SOURCE PROTECTION ZONES	
	Inner (SI)	Outer (SO)
Extreme (E)	S/E	SO/E
High (H)	S/H	SO/H
Moderate (M)	S/M	SO/M
Low (L)	S/L	SO/L

However, to the north of the gallery a 50 metre zone extends beyond the alluvial flat and up the hillside. It is clear that shallow subsurface flow (interflow) and surface runoff down the hillside would infiltrate the gravel at the foot of the slope, well within the 50 metre area. Therefore, to provide adequate protection to the gallery, the SI area must be extended up-gradient to include all the surface catchment which can drain directly into the 50-metre area. (Map 3).

The groundwater protection zones are obtained by integrating the two elements of land surface zoning (source protection areas and vulnerability categories) – a possible total of 8 source protection zones (see the matrix in the table below). In practice, the source protection zones are obtained by superimposing the vulnerability map on the source protection area map. Each zone is represented by a code e.g. **SI/H**, which represents an Inner Protection area where the groundwater is highly vulnerable to contamination. Four groundwater protection zones are delineated around the gallery at Minane Bridge (Map 3), as shown in the matrix below.
